Southampton Local Walking Infrastructure Plan (LWIP)

Southampton City Council

November 2023

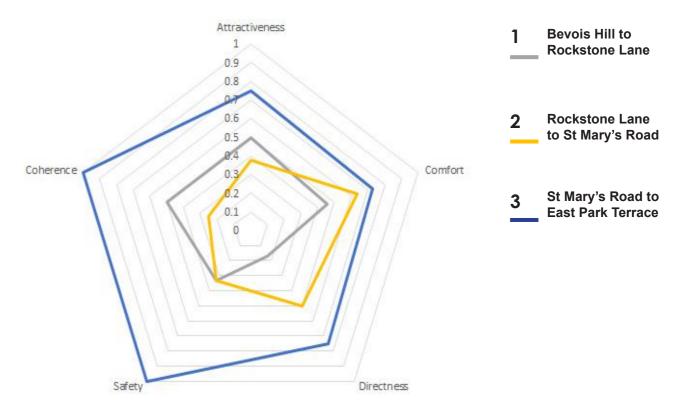
Figure 2.4 - Walking Route Audit Score by route segment

Figure 2.4 illustrates WRAT scores by route segment. Segment 3 scored the highest overall while segment 2 scored the lowest in terms of attractiveness and coherence. Segment 1 was found to be the least direct part of the route.

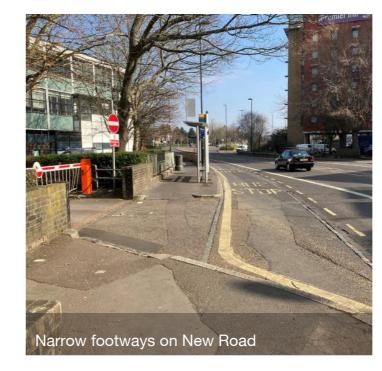
Figure 2.5- Walking Route Audit Score by route segment

Figure 2.5 illustrates WRAT scores by route segment. All sections of the route scored relatively poorly on attractiveness. Sections 1 and 3 scored poorly across all categories, indicating the need for a comprehensive set of improvements along this corridor.

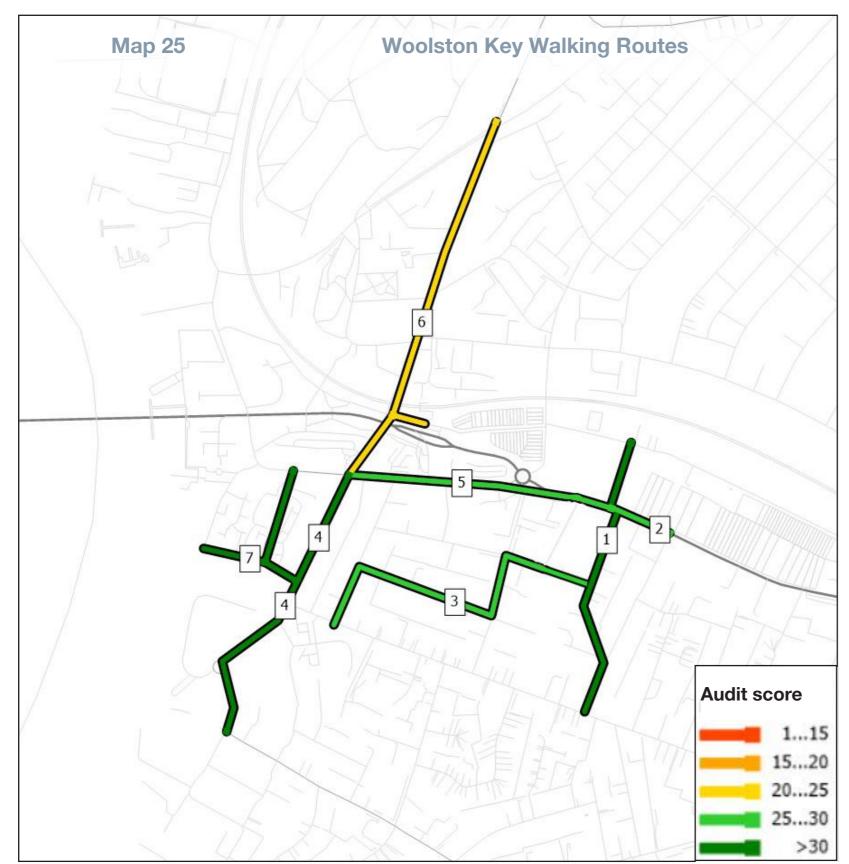
Existing Conditions and Key Issues

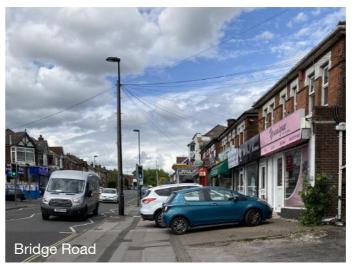
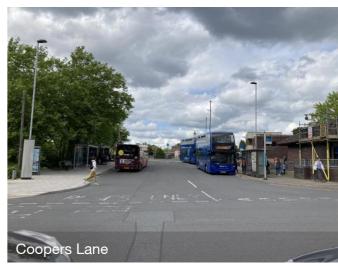
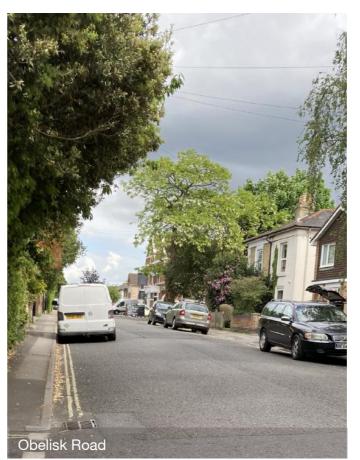
Existing Conditions and Key Issues

• Only greening located in private gardens and no space to accommodate on footways.
